ACCUTECH INSPECTION BUREAU LLC

INSPECTION REPORT

IMAGE GALLERY OF DEFECTS

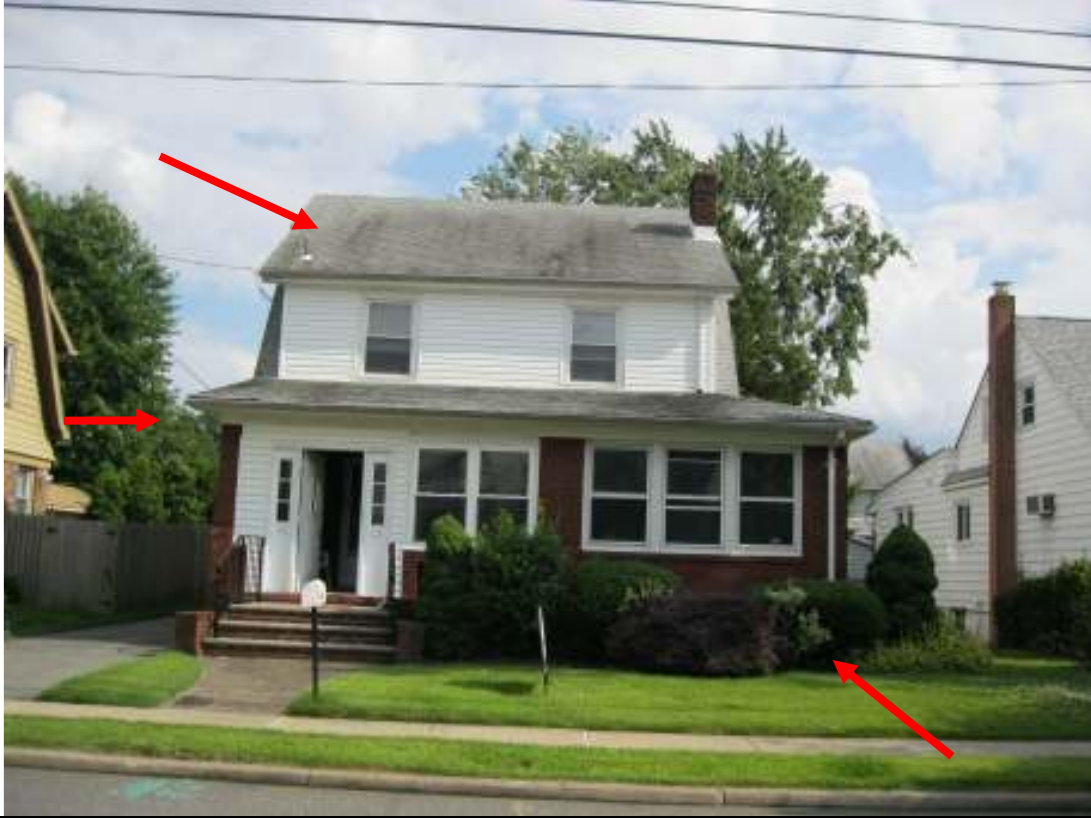
I ST251W0 Street Town Client Image # 01

Home Front Elev. Roof is bald and lower roof is low pitch roof. Overgrown vegetation.

Lower roof is a low pitch roof. Some previous leak stains were witnessed in the ceiling below. This is an inferior standard roof construction. Expect more leaks to manifest future in inclement weather conditions.

8. Exterior brick walls on both sides of the front steps are cracked.
9. Remove / prune all excessive vegetation on three sides of the home and tall trees that are a fall on roof risk etc.

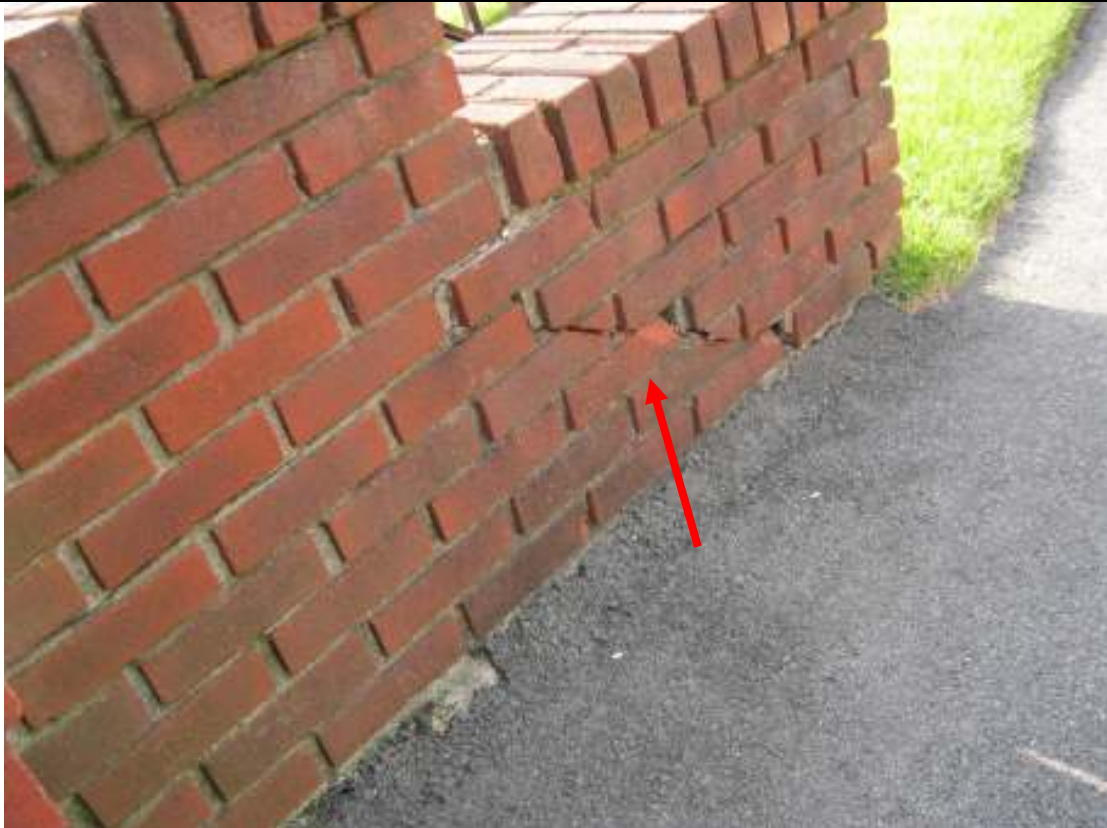
I ST251W0 Street Town Client Image # 02

Front steps broken on both sides. Also there is a crack in the middle of the main home & front porch

7. Improve child safety on all exterior and interior steps by improving / providing safe guard & hand railings, safe riser, / treads etc. Attic guard rail is deficient.

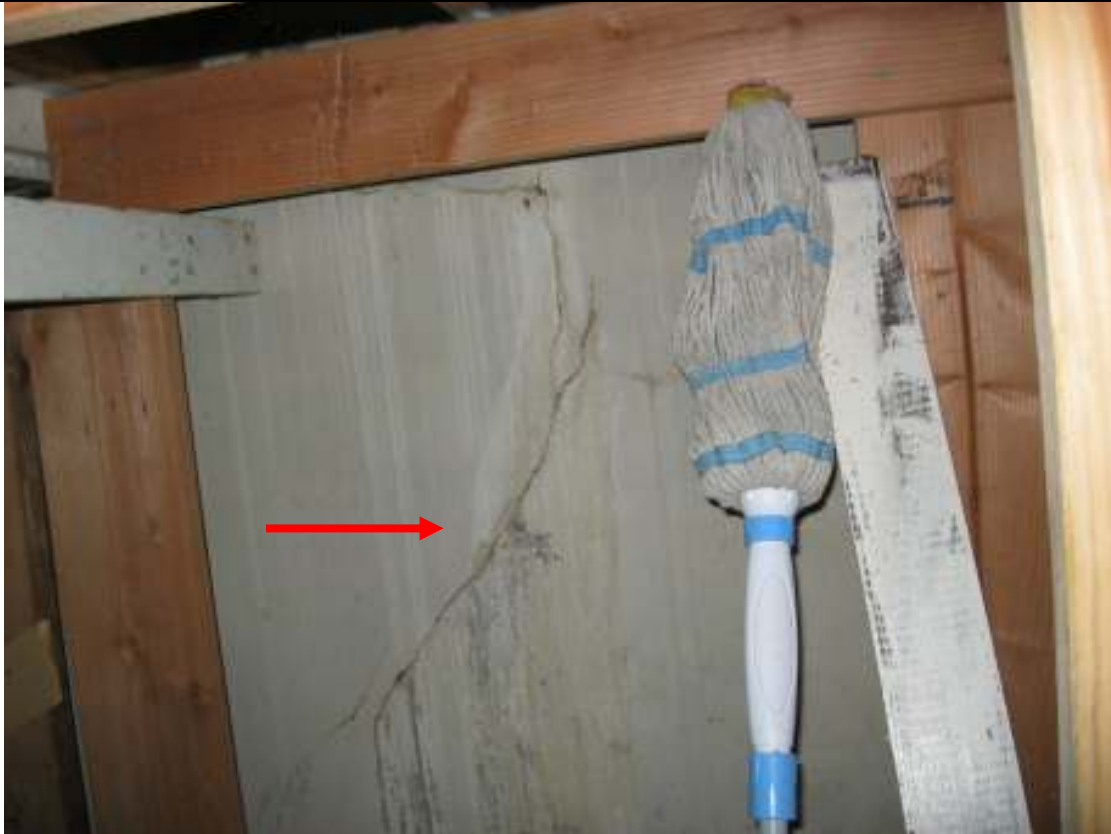
I ST251W0 Street Town Client Image # 03
Crack in the basement wall (left side)

There was a minor hairline crack visible at the time of inspection in the visible portion of the foundation wall. Although the cracks was less than 1/4" in width and do not seem to have any structural significance at this time, however this should be monitored.

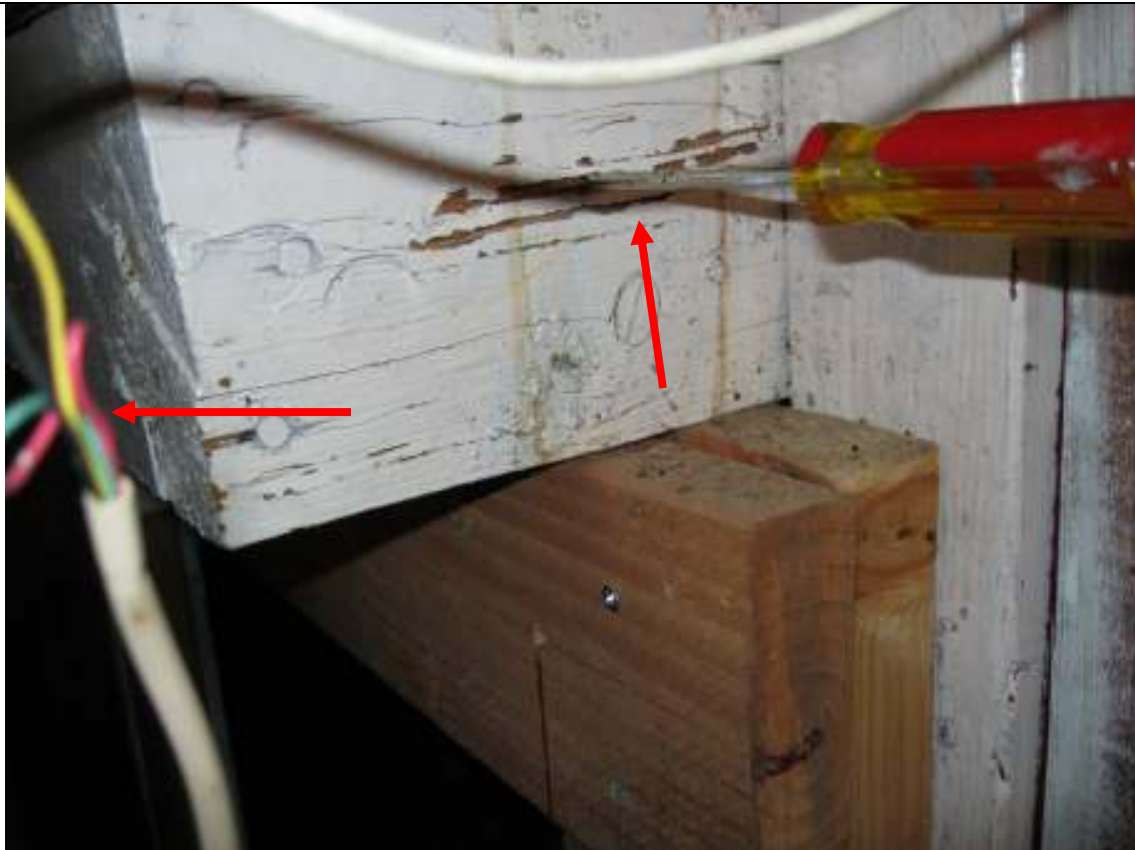
I ST251W0 Street Town Client Image # 04
Staircase to the basement is termite infested. Entire screw drive shaft penetrated. Loose Electrical wires etc

15. Continue to treat entire structure for immunity against WDI (termites) and get warranty against effectiveness of the treatment. Repair / Replace, all WDI infested components such as sill plate (at least 12'+). This is a very special repair. Replace entire termite infested staircase in basement.

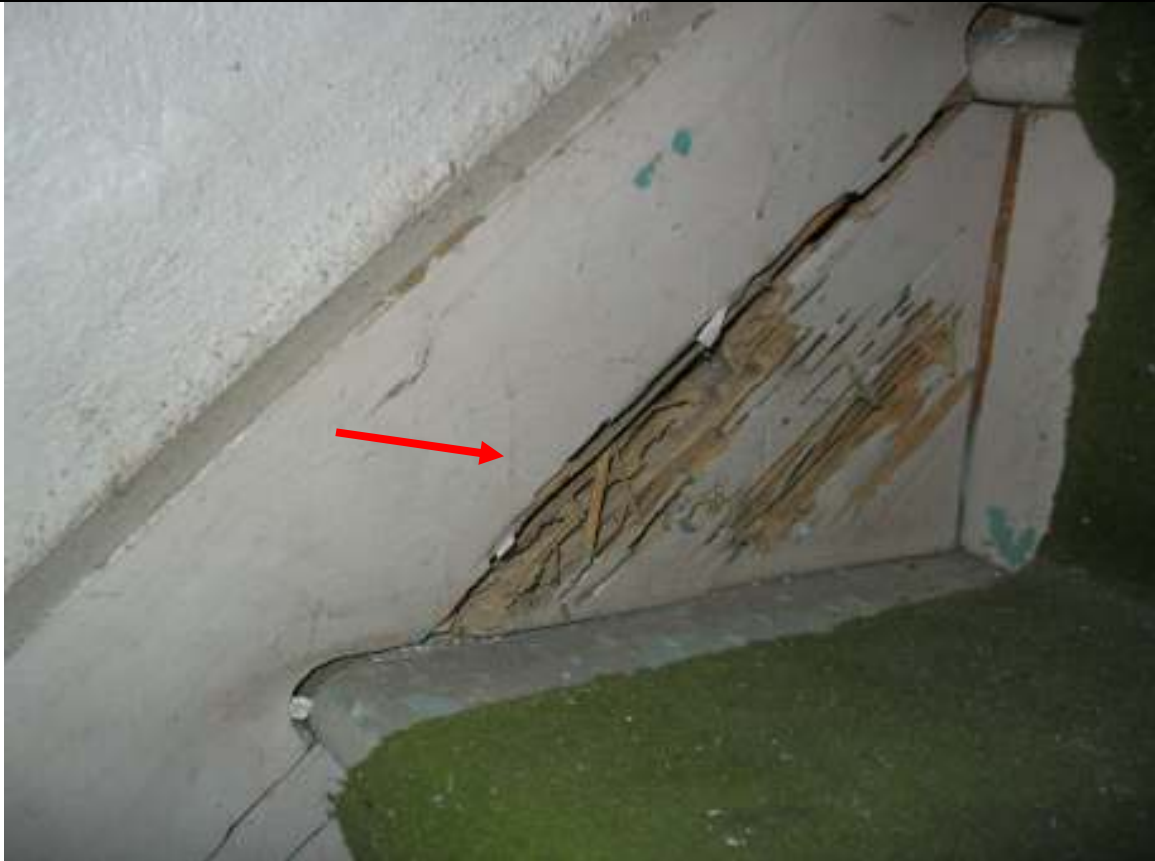
I ST251W0 Street Town Client Image # 05
Staircase stringer is termite infested

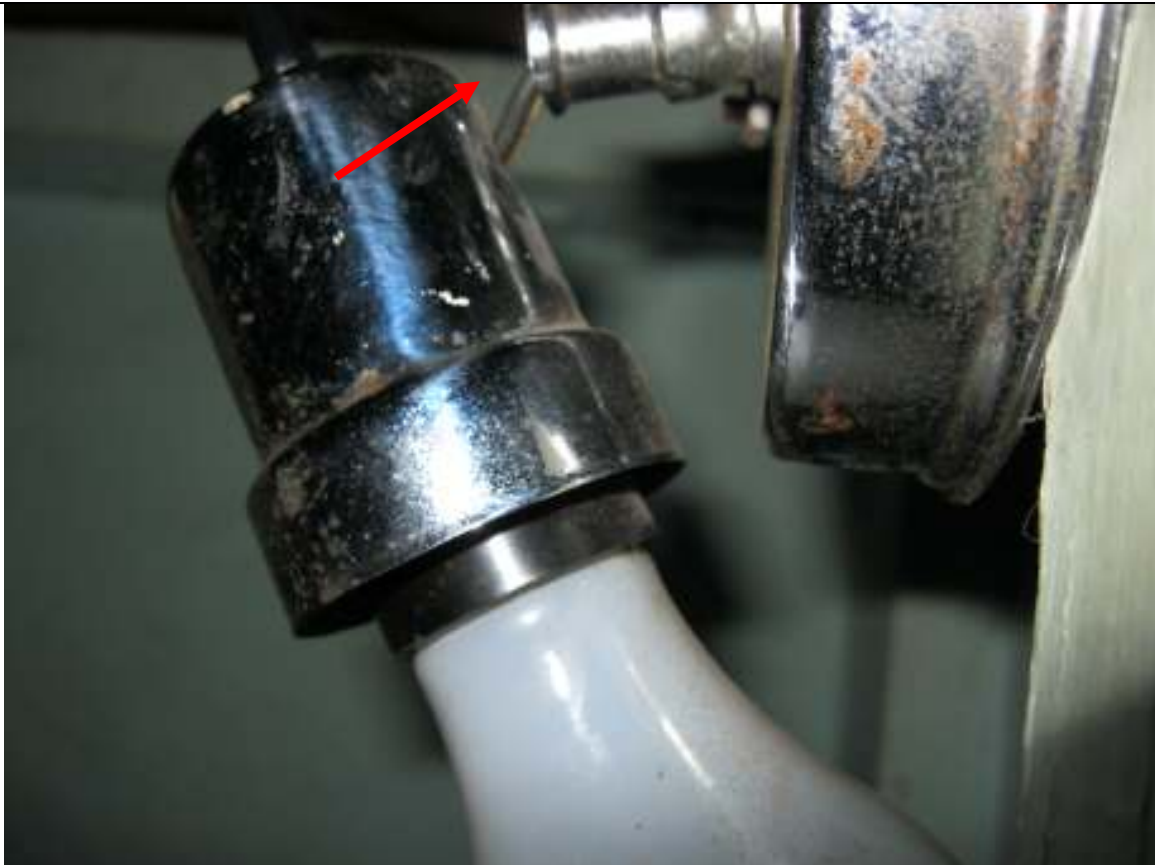
I ST251W0 Street Town Client Image # 06
Electrical lamp is broken at base. No lens

18. Repair / replace / improve all electrical deficiencies such as loose electrical fixture in basement bathroom, defective ceiling light in the attic etc.

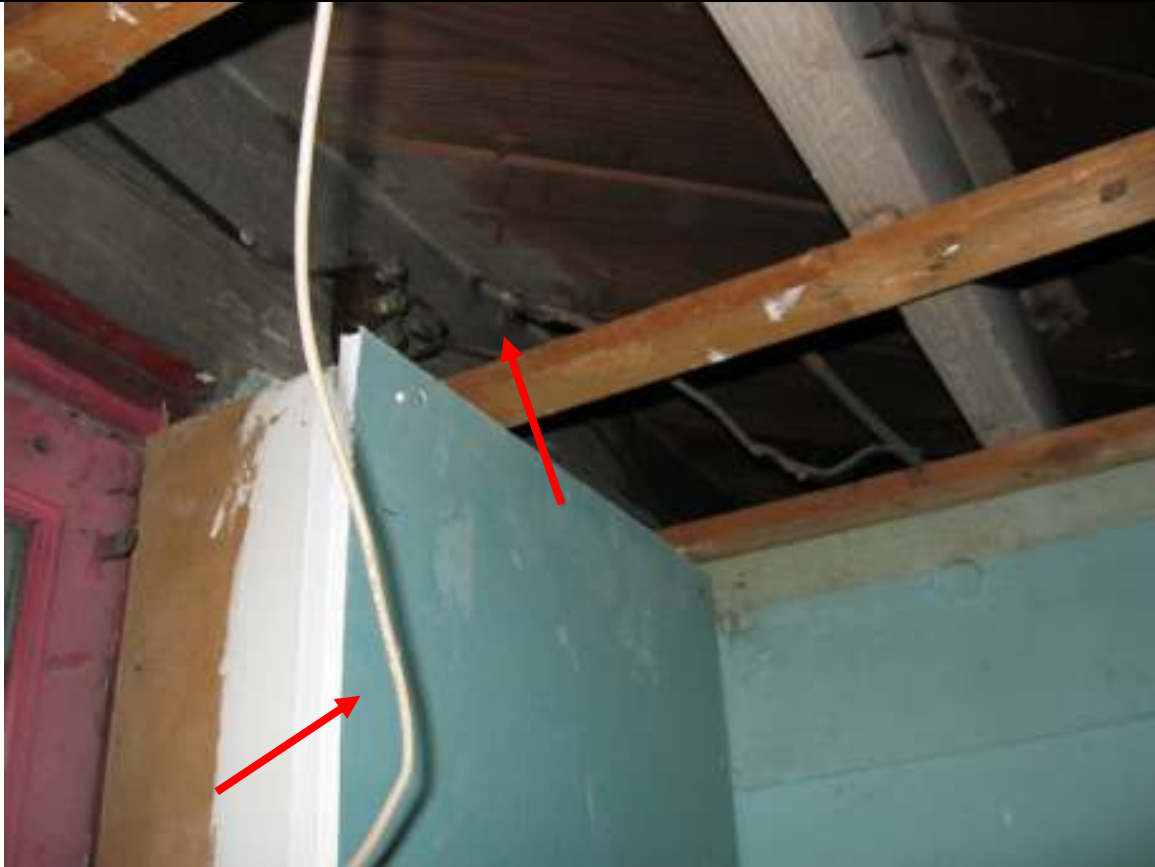
I ST251W0 Street Town Client Image # 07
Open electrical wire. Paper base sheetrock glued to the basement walls. Loose electric wiring

Paper based sheet rock has been laminated on the concrete walls in the basement which is an improper construction specification (It may be hiding wall condition).

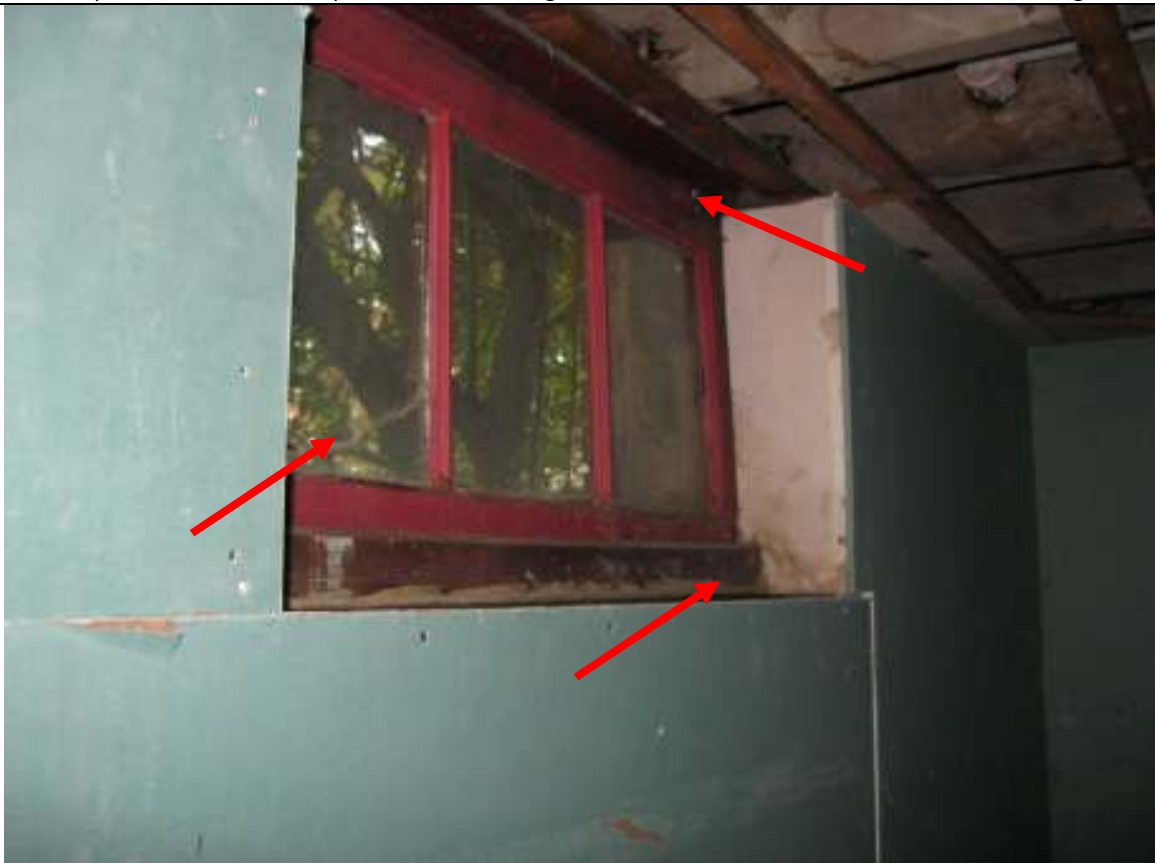
I ST251W0 Street Town Client Image # 08
Broken basement window glass. Leaking at the sill

10. Replace / repair all inoperable / deficient windows such as all windows in basement that are aged etc. The hardware is missing / broken glass etc. All windows are of low quality specifications. Recommend replacing windows, particularly in bedrooms such as on the right side on top bedroom (It does not close). One window glass in basement is broken.

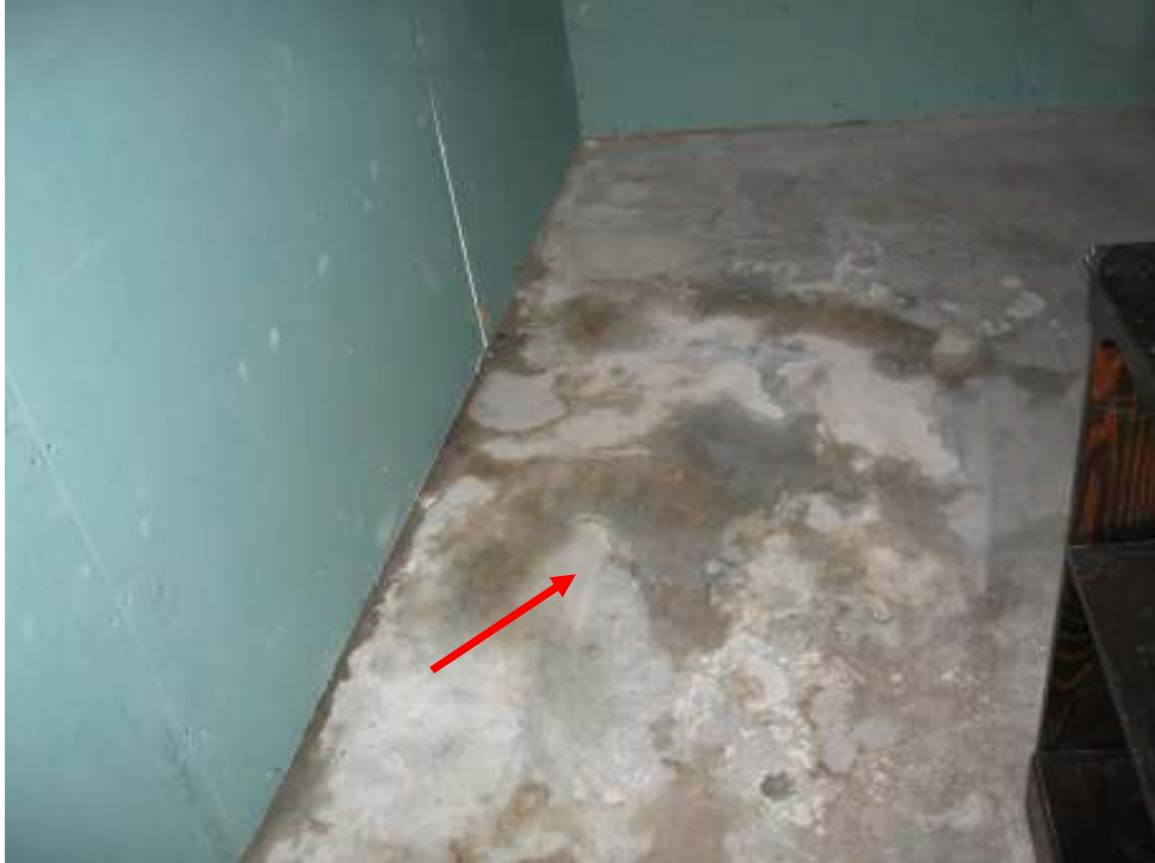
I ST251W0 Street Town Client Image# 09
Water stains on floor previous flooding

There is some visible staining of previous water penetration in the basement. Roof & surface water drainage conditions should be effectively maintained to prevent any moisture / water intrusion into the foundations, as efflorescence was witnessed on walls. Foundation appears to have a history of previous moisture intrusion in to it. In a one-time visit meaningful conclusion on the quantum of moisture penetration may not be arrived at decisively. Future lapses of water penetration cannot be ruled out. It is very probable, that maintaining dry foundations may not be achievable. Maintain property slope (minimum recommendation 6% or better) to assist arresting surface run off water migration into foundations. Extend downspouts to lead water 10' or more away from the foundations, and manage better roof water shedding away from the foundations. The property has recently been rehabbed. Most components that are typically inspected bare have been closed up (sheet rock etc) and hence the visibility is severely limited. The condition is a suspect for integrity.

2. Arrest heavy water migration into the foundations. It may be necessary to re-grade lot, improving roof water shedding management / improving wall porosity for water imperviousness etc. Slope all water away from home.

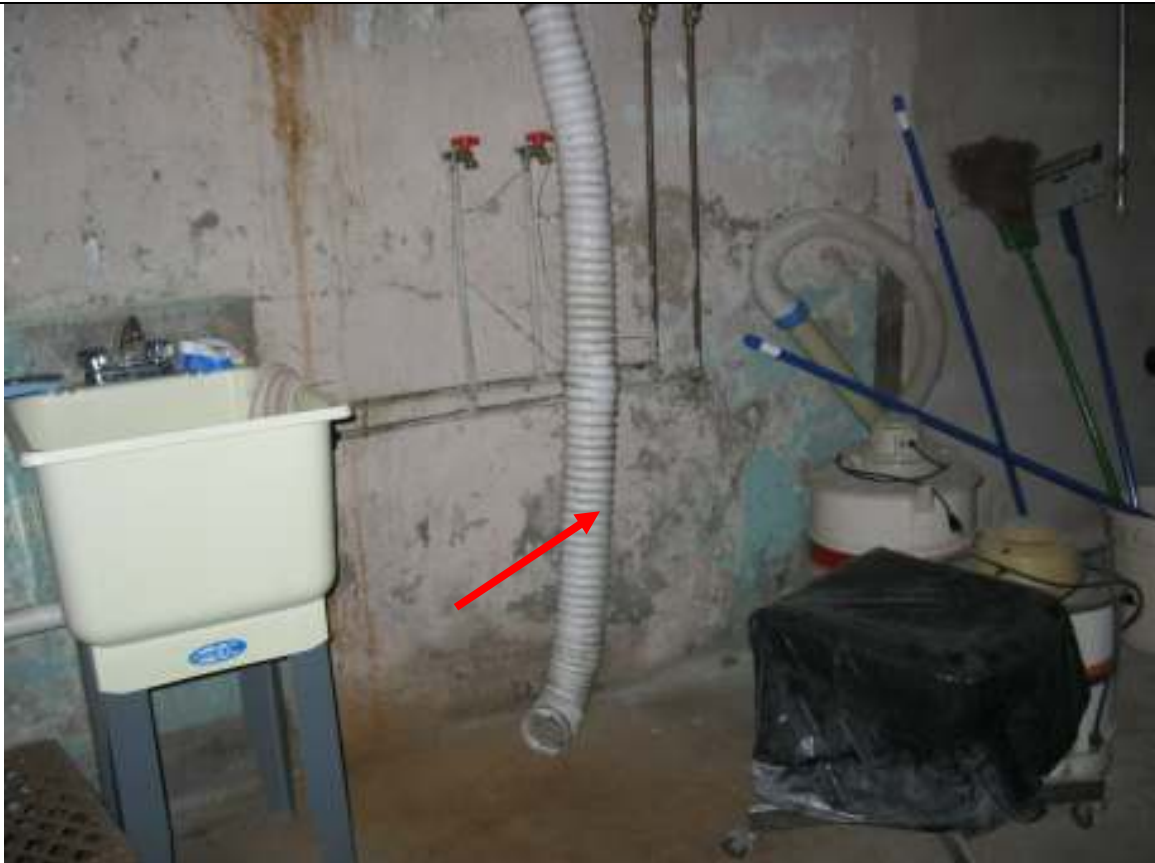
I Image Street Town Client # 10
Water penetration into basement. No laundry appliances

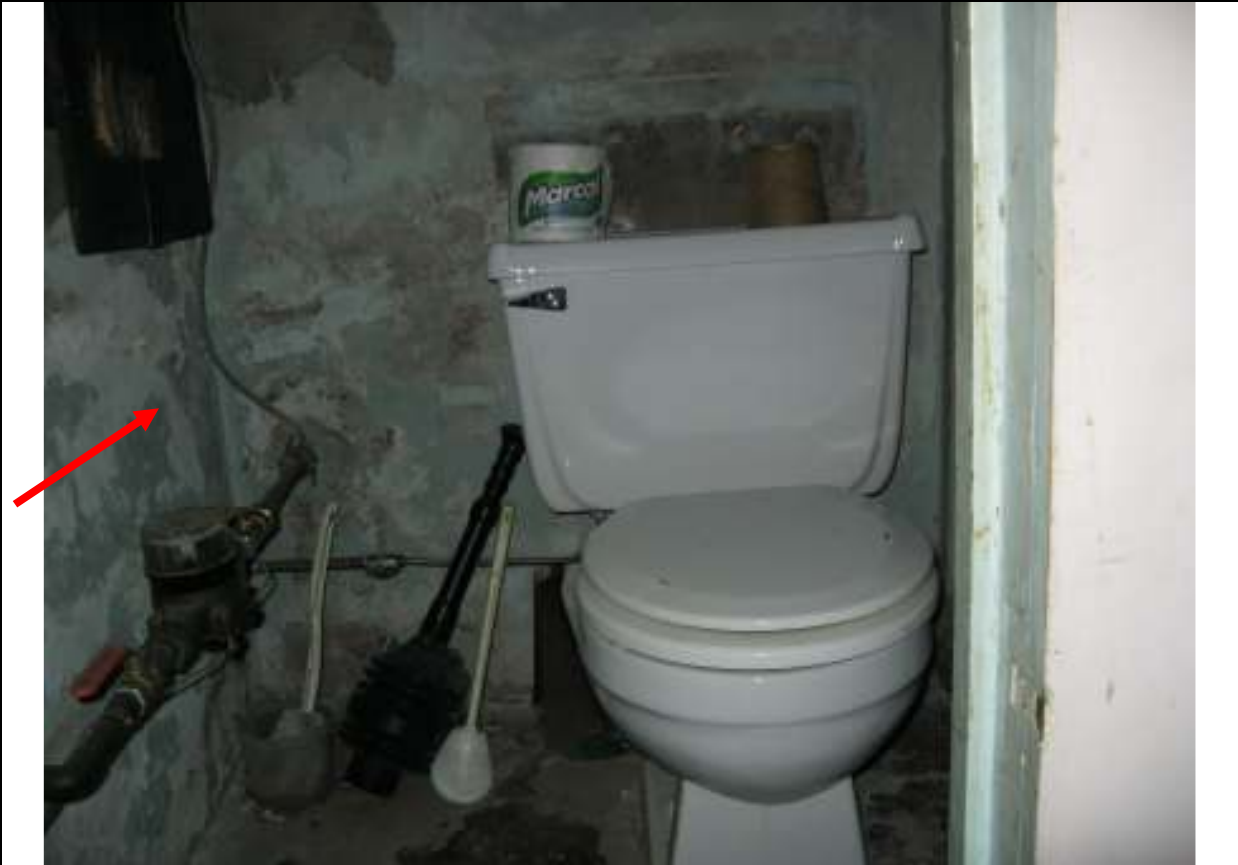
I ST251W0 Street Town Client Image# 11
Water penetration in basement. Water closet raised 12"+ above basement floor

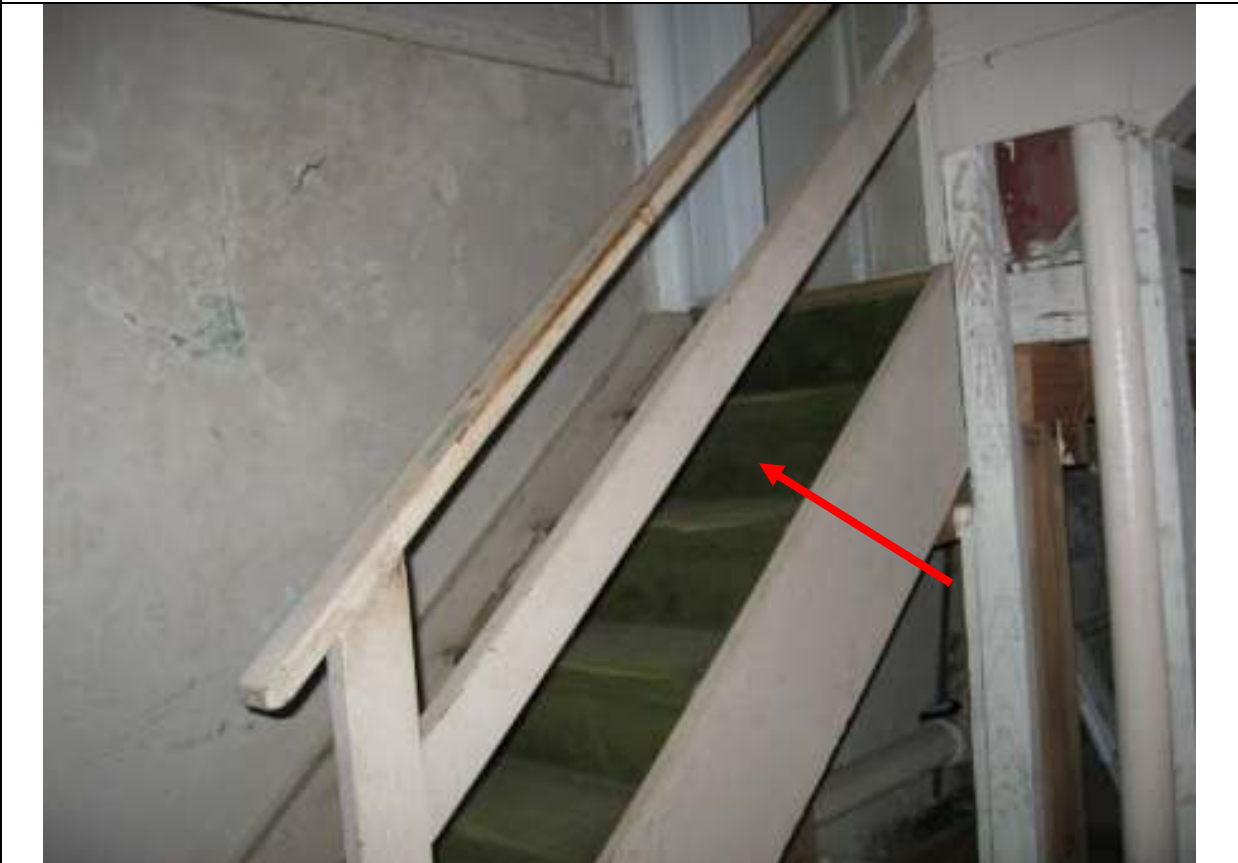
I ST251W0 Street Town Client Image # 12
Staircase railings do no meet current construction standards

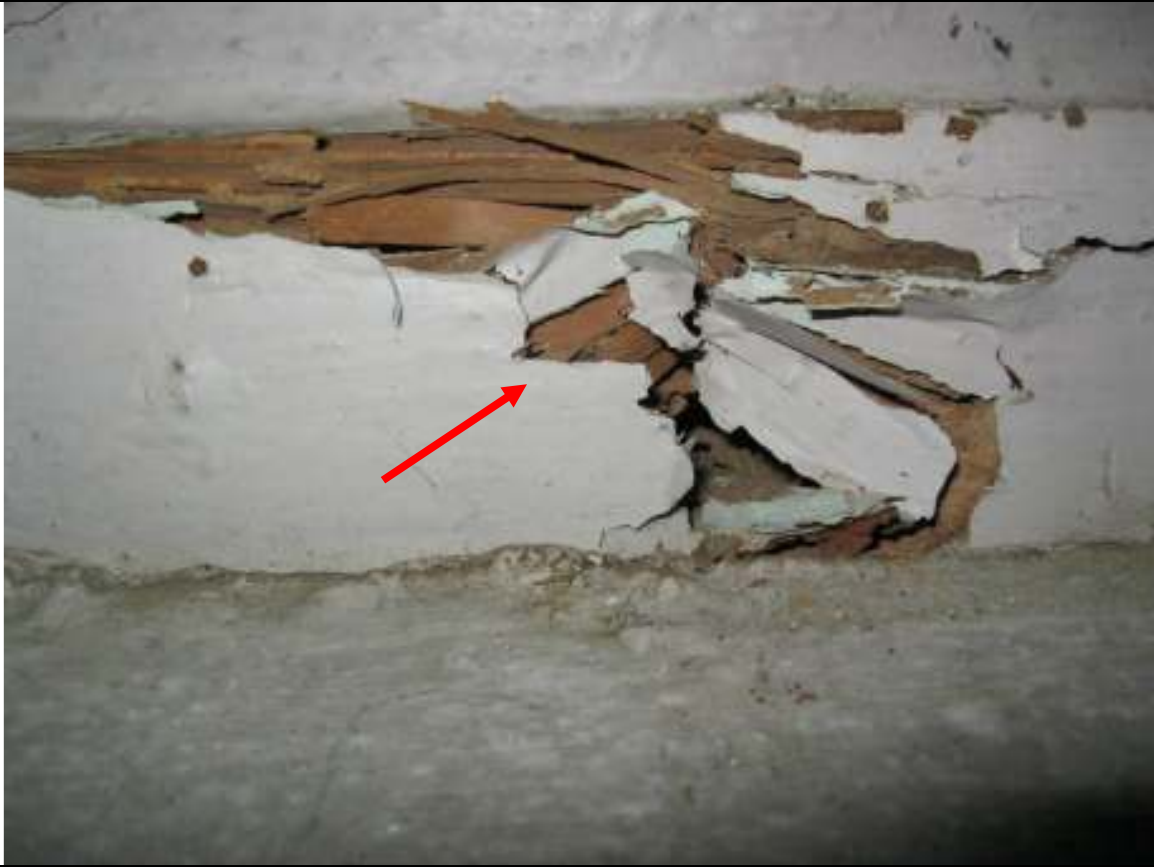
I ST251W0 Street Town Client Image # 13
Termite infested sill plate

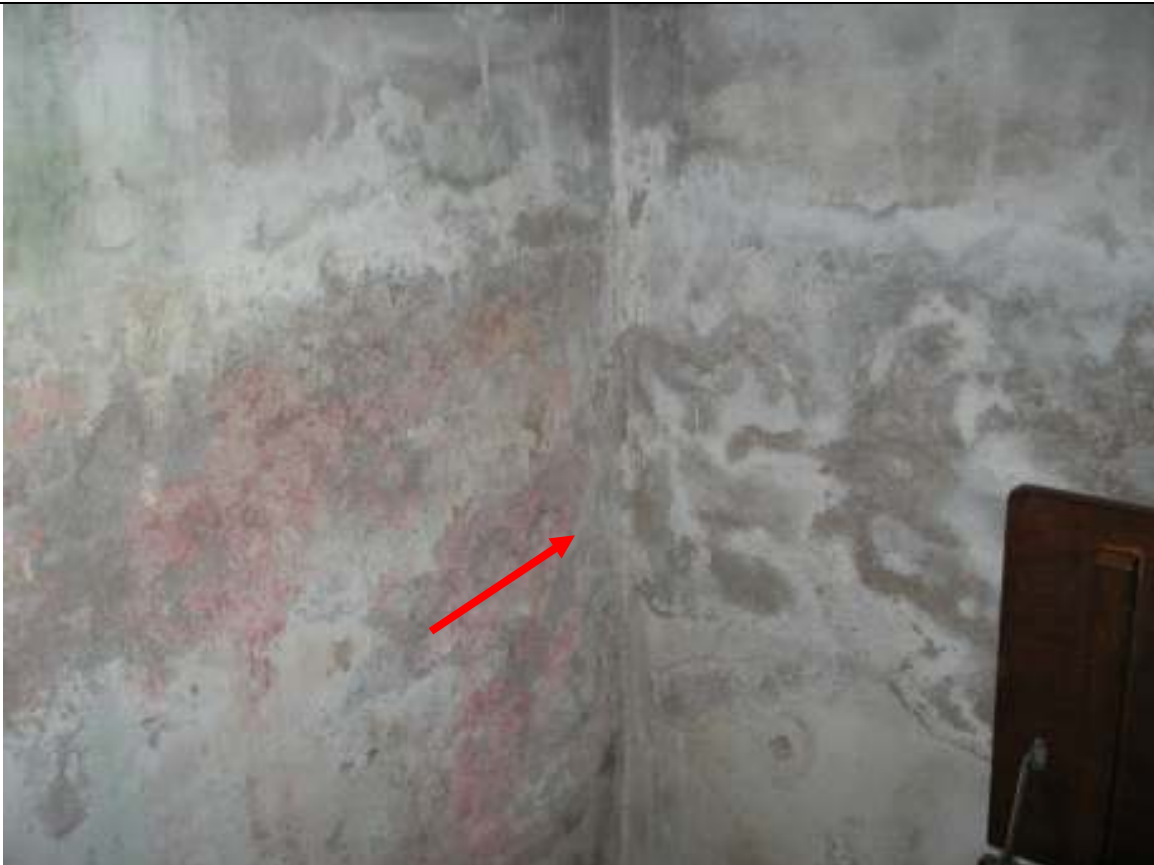
I ST251W0 Street Town Client Image # 14
Water penetration the basement walls

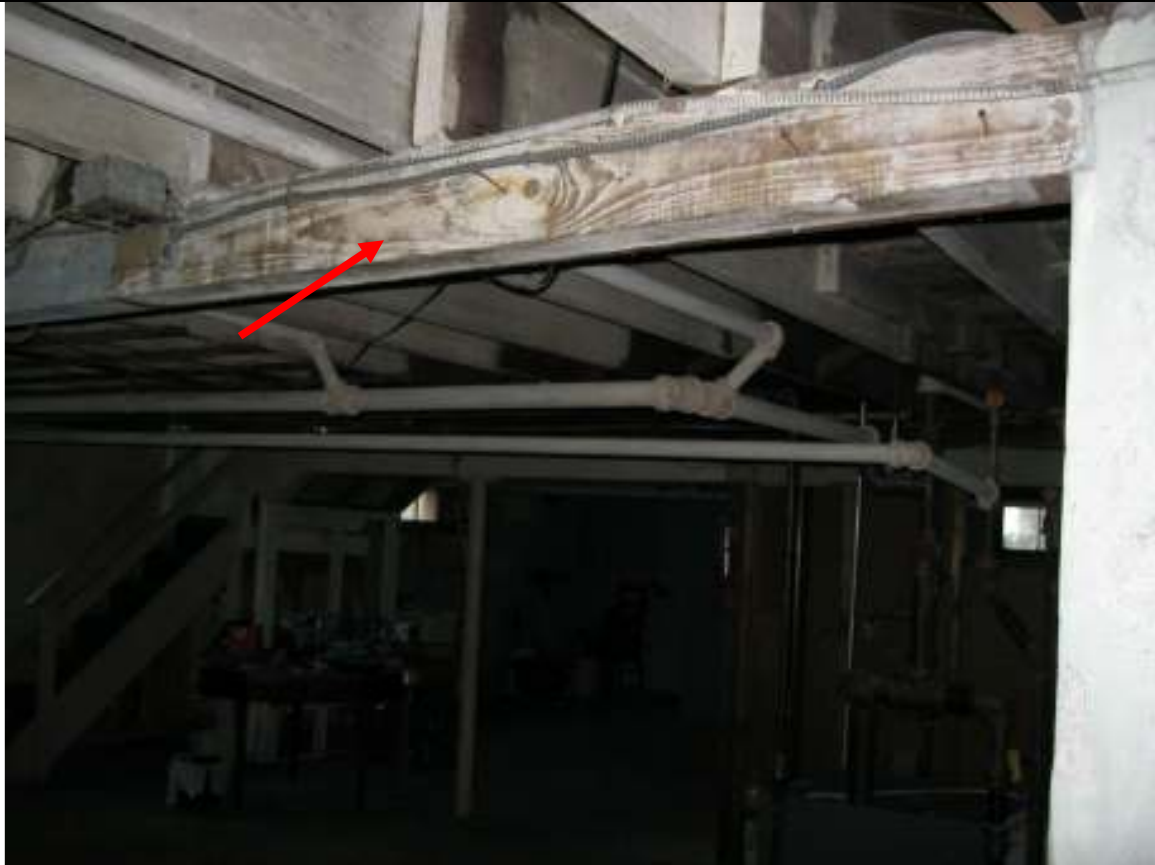
I ST251W0 Street Town Client Image # 15
Joists have been primed after the fire damage. Undersized beam (load bearing wall has been removed)

The property appears to have suffered some fire damage in the recent past. Joists in the basement were coated with post fire coatings for smoke inhalation. Consult fire department / town hall / insurance carriers for further information.

5. Install missing weep holes in the brick veneer.
6. Repair / replace / reinforce all substandard / aged / racked / structural deficiencies, such as undersized garage roof structure, Shallow undersized beam in basement (load bearing wall has been removed between the main basement and front room); racked and squeaking main staircase, termite infested staircase to basement, sagging and squeaking floor structure, cracked concrete block foundation walls in garage, cracks in the wall (between main structure and front porch) etc.

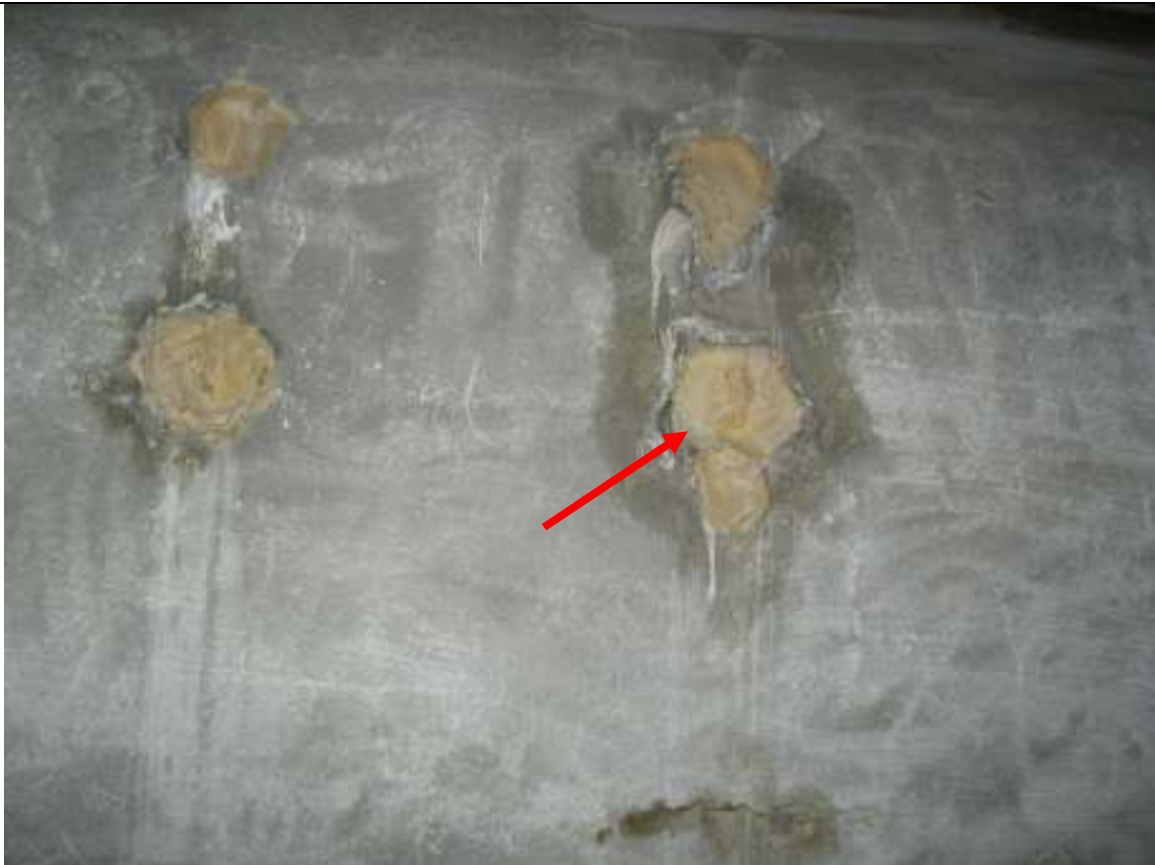
I ST251W0 Street Town Client Image # 16
Previous oil tank lines penetration through these lines

Please verify with town hall about the presence, removal, & compliance, of an oil tank, if any. Searching / testing oil tanks / soil etc are beyond the scope of this inspection. Recommend testing soil.

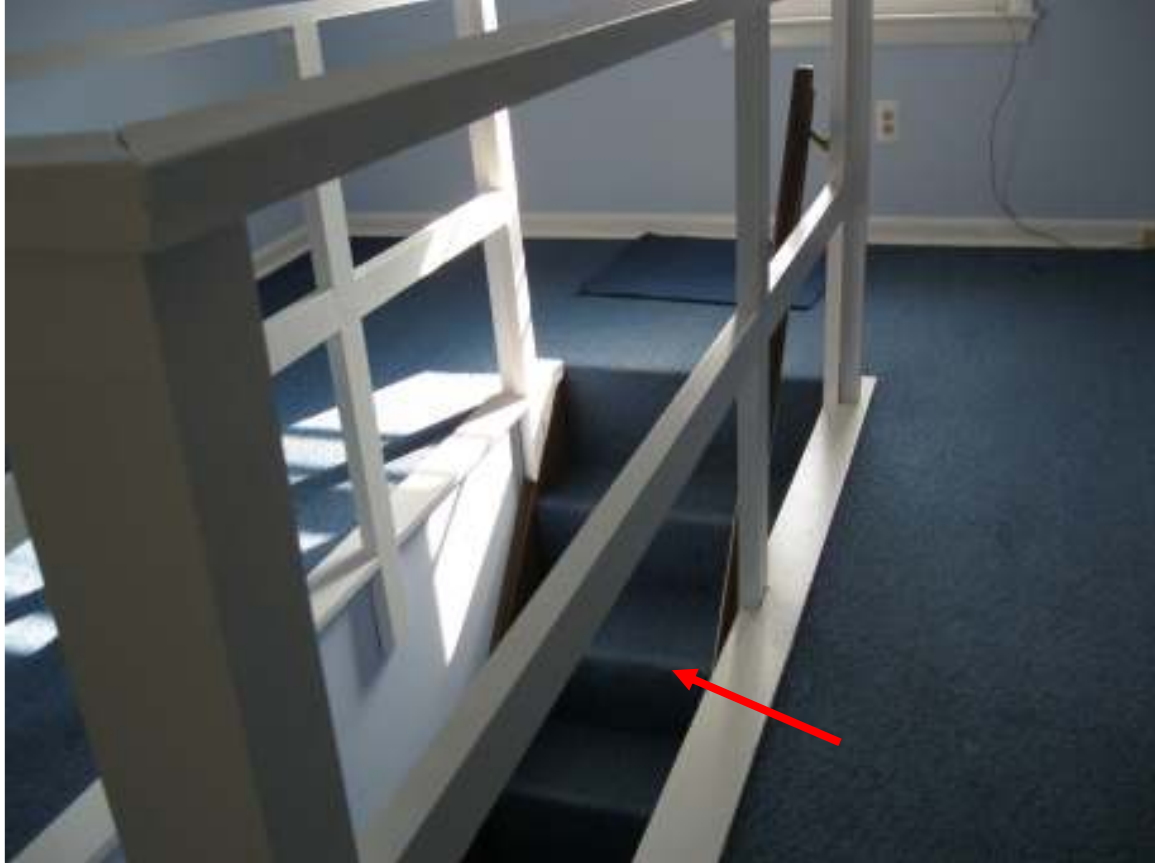
I ST251W0 Street Town Client Image # 17
Stair case guard railings in the attic do not meet current construction standards

This inspection is not directed at code related issues. Attic has been converted for habitation, Average ceiling height is less than 7' 6", staircase is less than 3' wide, and guard railing does not meet current construction standards etc. Recommend reconfirming with town hall as to this property's acceptability / compliance / grandfathered status.

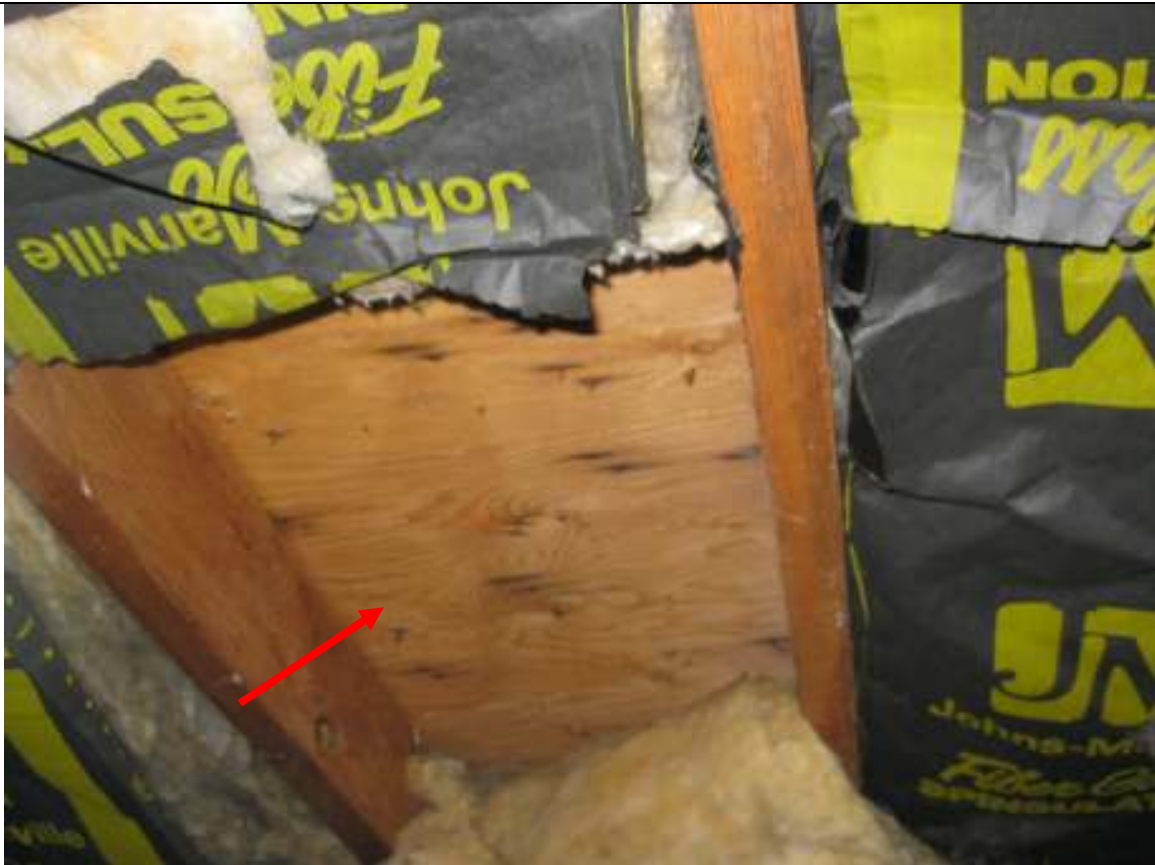
I ST251W0 Street Town Client Image # 18
Roof decking has been replaced with plywood after the fire in the top level. Insufficient Insulation

11. Improve / add to, insufficient / missing insulation in attic and basement (floors).
12. Improve on deficient attic ventilation. Attic temperatures are more than recommended (Ambient + Maximum 10 d F).

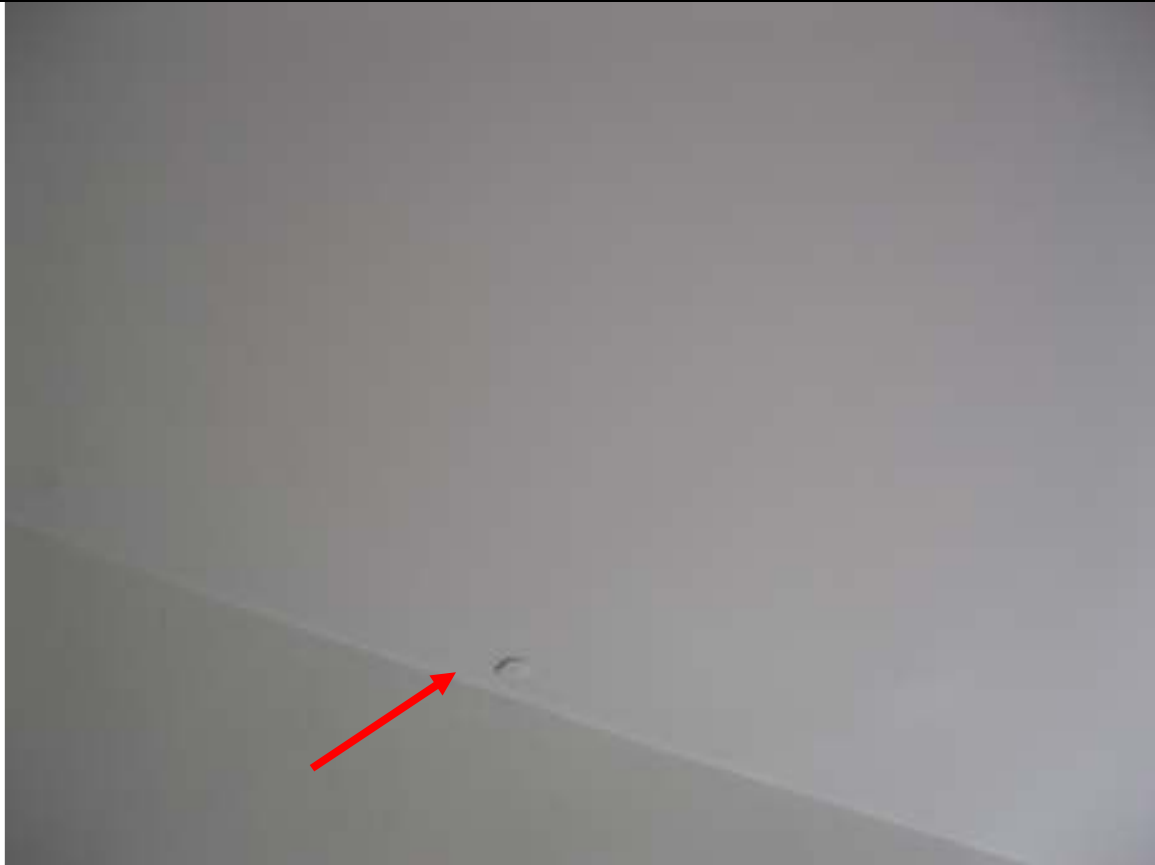
I ST251W0 Street Town Client Image # 19
Ceiling on the second floor is new sheet rock but the walls are plaster on wood lath.

13. Repair/replace/improve all carpentry issues such as deficient hardware on attic doors etc.
14. Repair / replace / fix / patch all deficiencies such as holes / cracks / broken / torn off plaster / sheet rock / wall covering on the walls / ceilings etc. This is an antiquated lath on wood slates system.

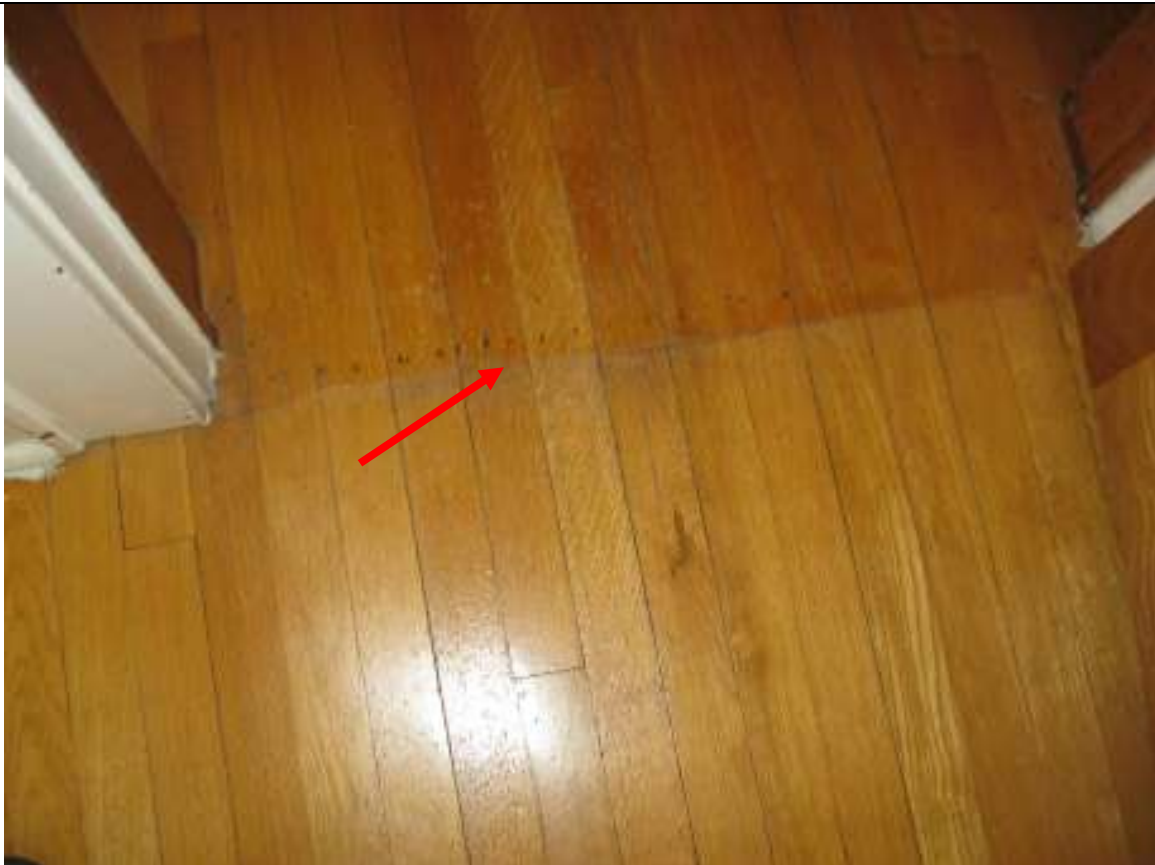
I ST251W0 Street Town Client Image # 20
Hard wood floor on second floor, finished amateurishly

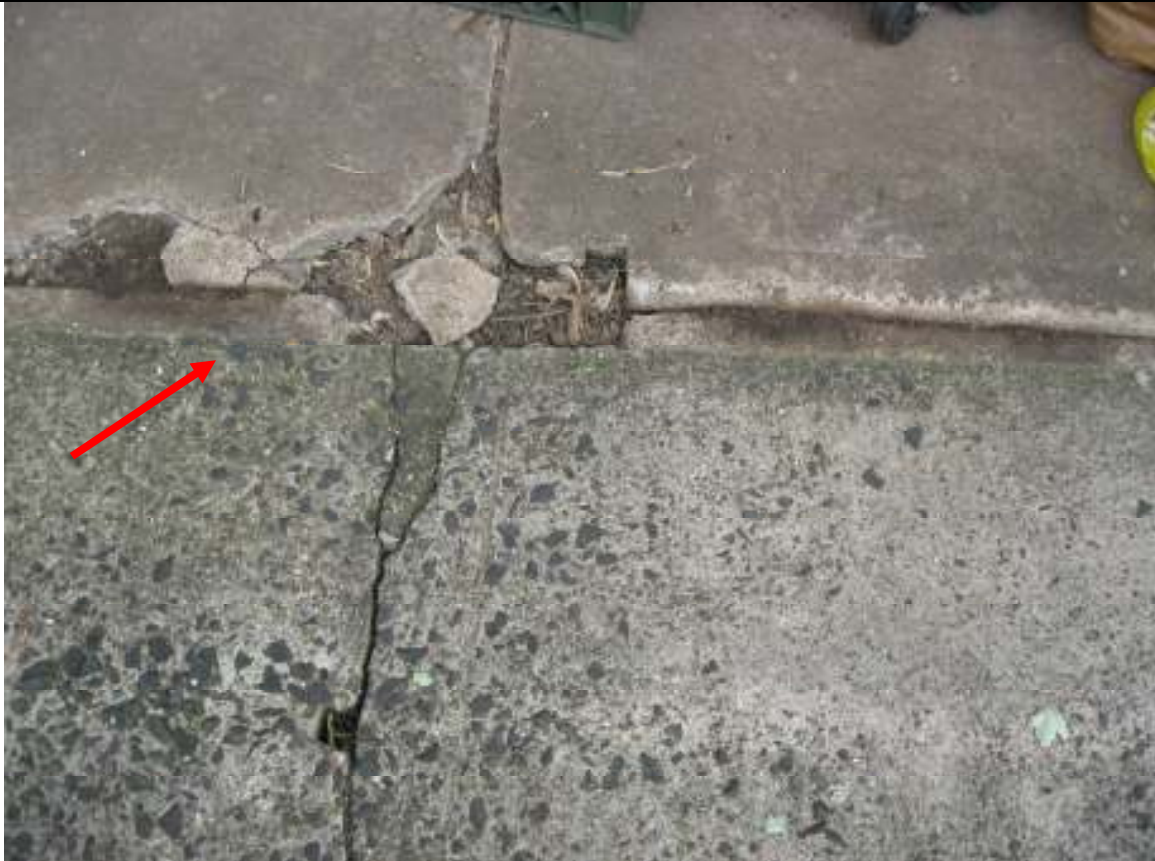
I ST251W0 Street Town Client Image # 21
Garage floor slab is cracked

1. Repair / replace / resurface deteriorated / broken / uneven, aged driveway (asphalt and concrete), sidewalk and garage floor slab etc. It can be a trip hazard.
