ACCUTECH INSPECTION BUREAU LLC

INSPECTION REPORT

IMAGE GALLERY OF DEFECTS

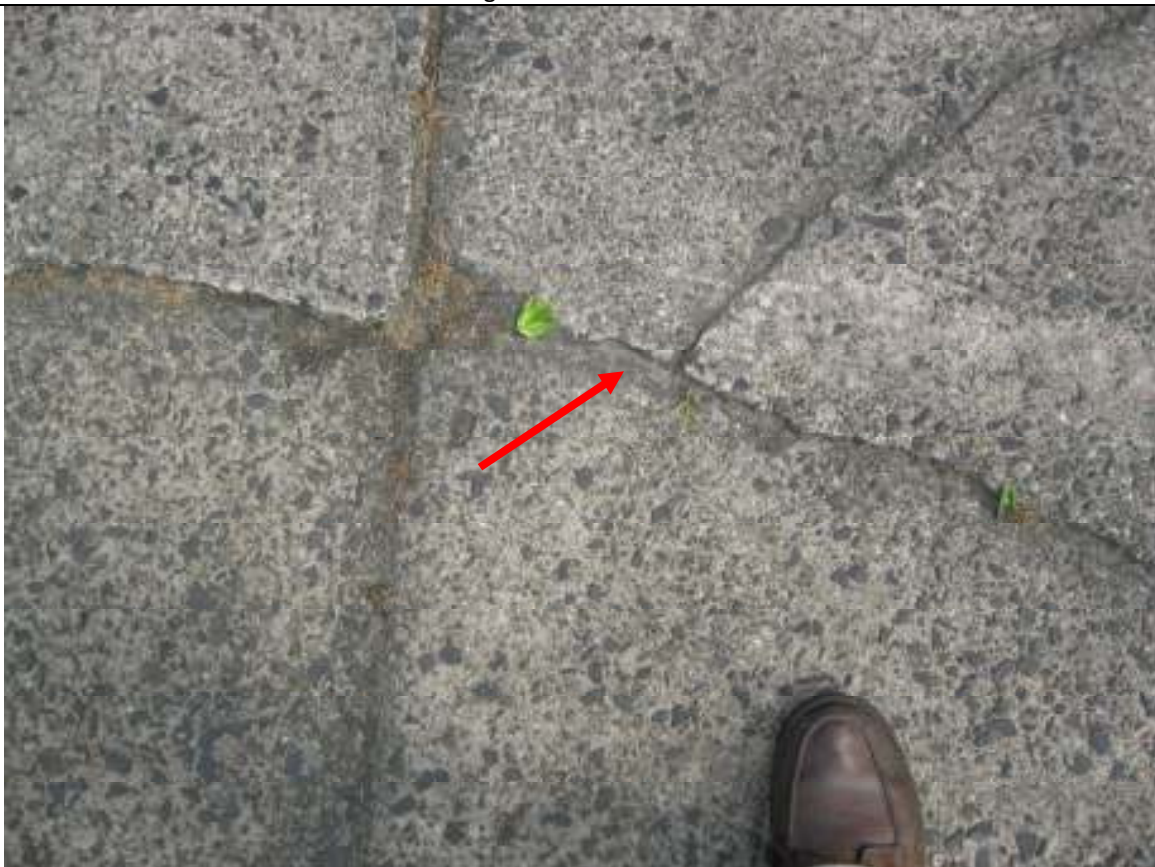
I ST251W0 Street Town Client Image # 22
Asphalt and concrete driveway is cracked

1. Repair / replace / resurface deteriorated / broken / uneven, aged driveway (asphalt and concrete), sidewalk and garage floor slab etc. It can be a trip hazard.

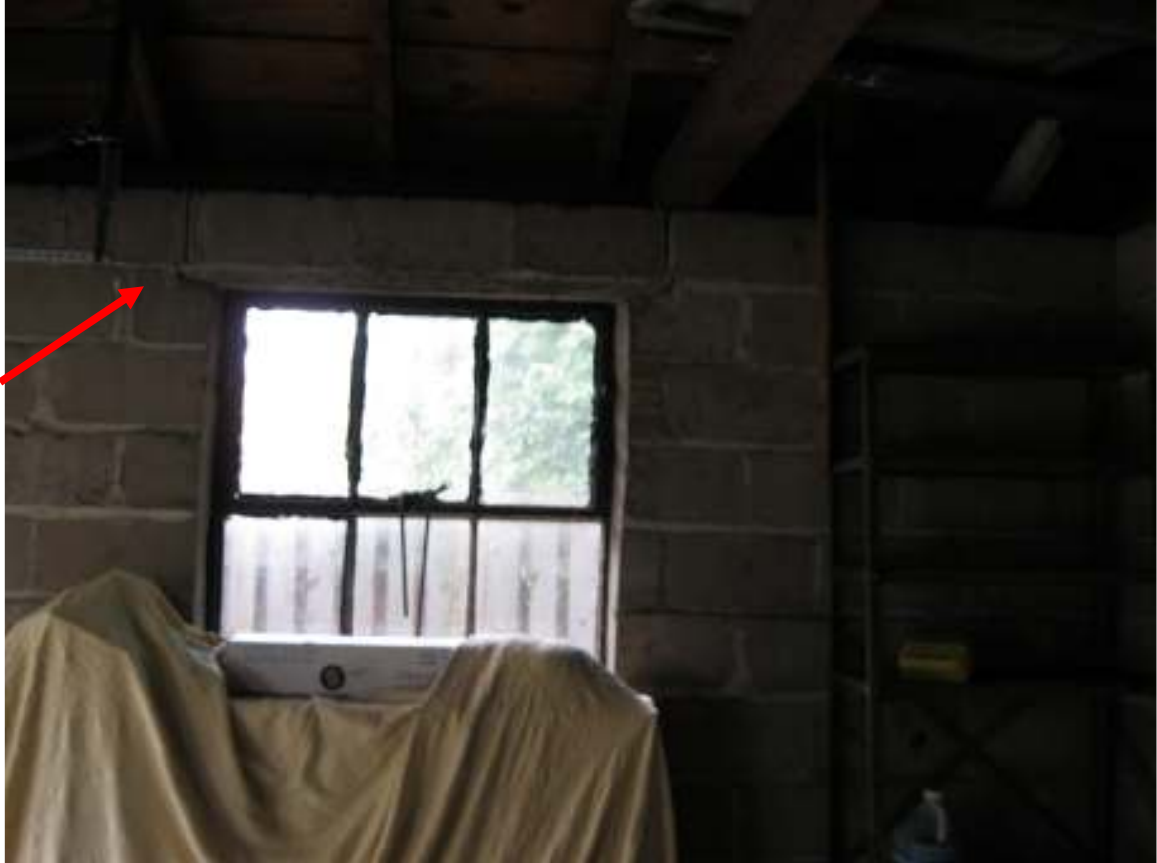
I ST251W0 Street Town Client Image # 23
Cracked bock wall above window in garage

5. Install missing weep holes in the brick veneer.
6. Repair / replace / reinforce all substandard / aged / racked / structural deficiencies, such as undersized garage roof structure, Shallow undersized beam in basement (load bearing wall has been removed between the main basement and front room); racked and squeaking main staircase, termite infested staircase to basement, sagging and squeaking floor structure, cracked concrete block foundation walls in garage, cracks in the wall (between main structure and front porch) etc.

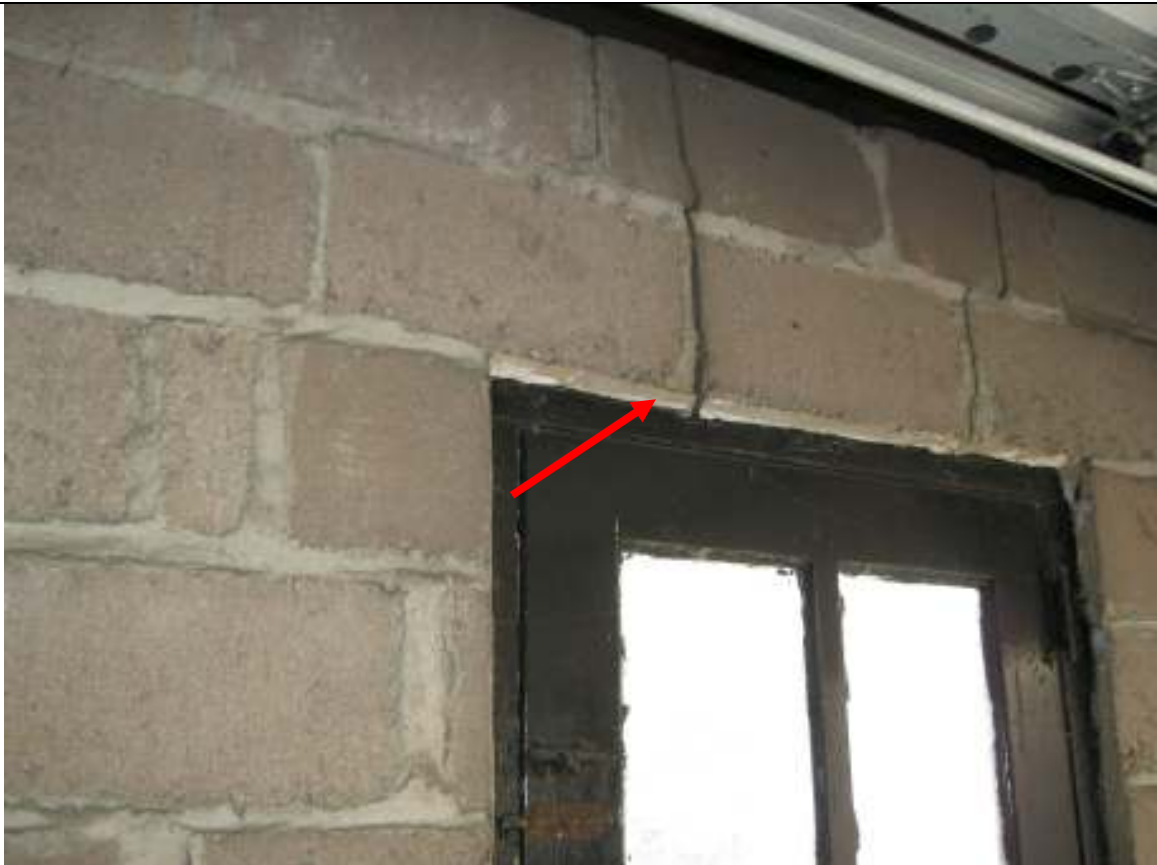
I ST251W0 Street Town Client Image # 24
Cracked concrete block wall above the door
